Municipality of Wawa

MONTHLY REPORT – NOVEMBER 2023

**Re: Municipality of Wawa Municipal Water Supply Intake Replacement
Intake Pipe Interior Inspection**

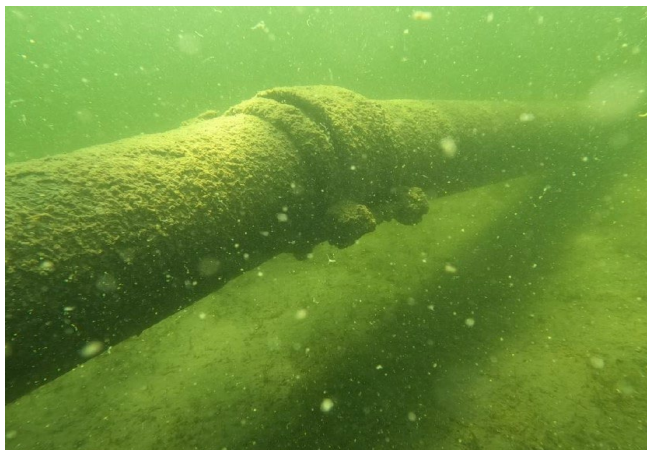
The exposed section of emergency intake pipe (suspected to be cast iron) revealed offset joints in some locations (Photograph 1). The intake structure was observed to consist of an intake bell mouth fitted with bar screens within a timber crib. Watech noted the bars to be inundated with zebra mussels (Photograph 2) as well as some softness in the timbers. Watech identified the timber crib base as comprised of “wooden boards” with some boards either missing or broken.

Photograph 1: Offset Joint in Emergency Intake Pipe

The emergency intake pipe is in poor condition as offset joints are visible along the exposed section of pipe and it appears to have been abandoned by insertion of a mechanical plug. The intake structure appears to be intact but deteriorated with the bar screens on the intake bell mouth being inundated with zebra mussels.

As results from the external inspection of the emergency intake pipe and intake structure indicate that this infrastructure is in poor condition, it is recommended that the emergency intake is decommissioned.

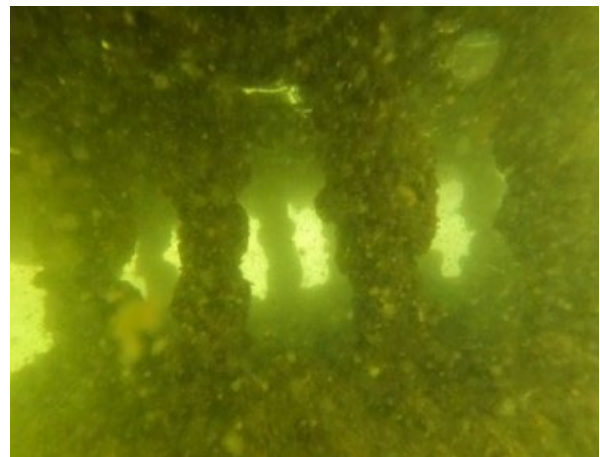
Photograph 2: Marine and Zebra Mussel Growth on Emergency Intake Bar Screen

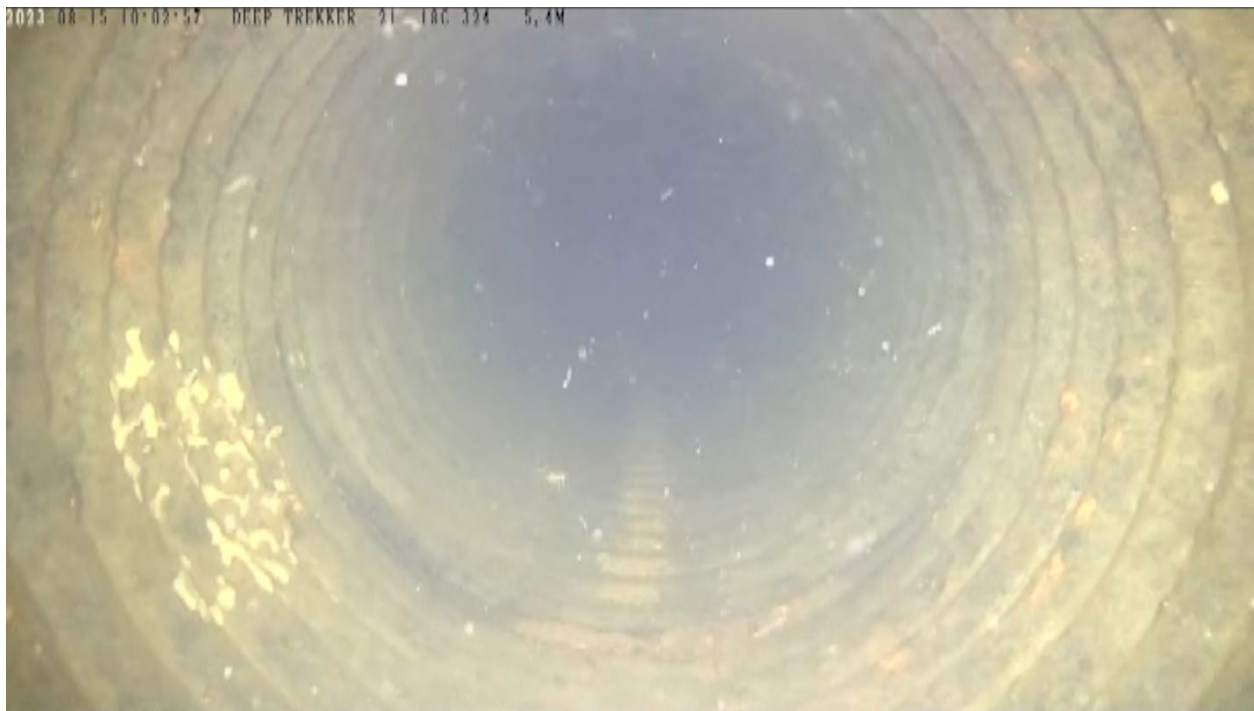
During the initial inspection, the ROV was piloted a distance of approximately 85m into the duty intake pipe from the LLPS, limited by the length of tether included with the ROV to roughly half the length of the duty intake pipe. Minimal sediment and marine growth were observed along the length of the pipe inspected. No obvious signs of pipe failure were observed. The inspection revealed that the pipe material is CSP, which differs from the materials noted in available documentation (i.e. cast iron and asbestos cement).

Photograph 3: Duty Intake Pipe – Minimal Sediment Along Invert

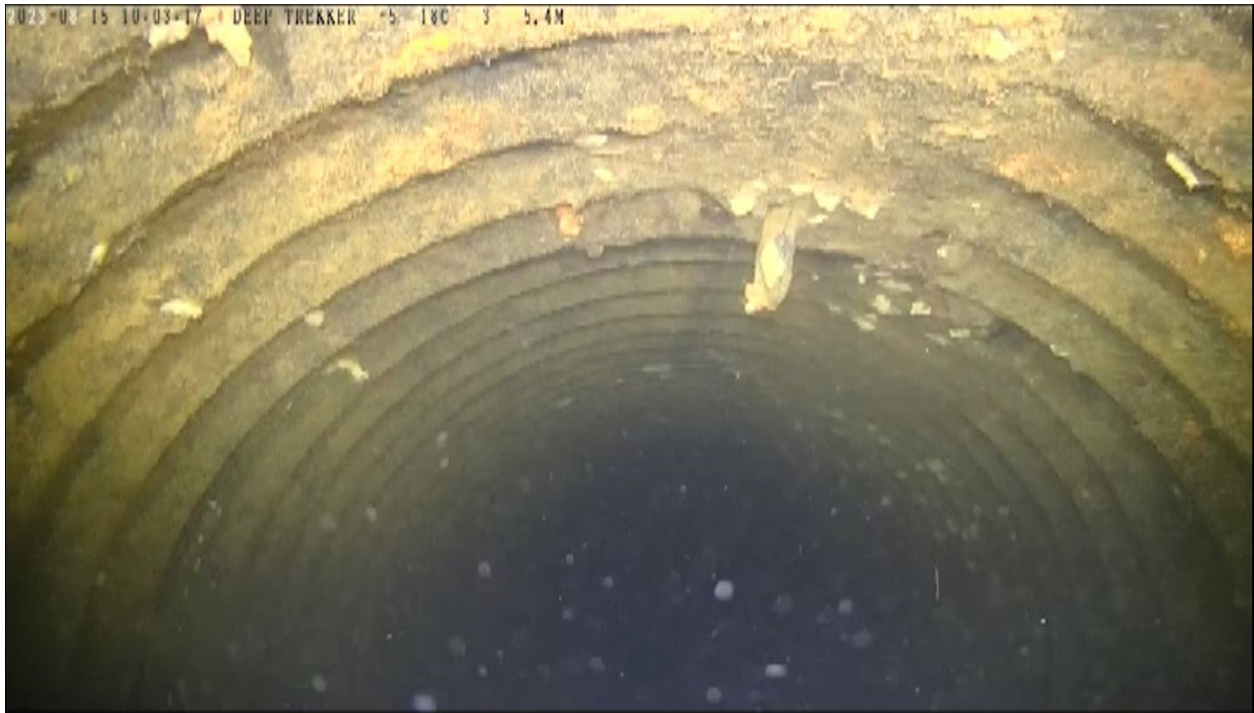
Photograph 4: Possible Pipe Puncture Observed at the Obvert (top) of the Duty Intake Pipe

The entire length of duty intake pipe is CSP which differs from the available documentation identifying a combination of cast iron and asbestos cement pipe. It appears that the duty intake pipe is in fair condition with no obvious indications of pipe wall failure (with the exception of a possible puncture) or offset joints; however, evidence of corrosion (i.e. rust spots) is observed throughout. Some pipe anchors, securing the intake pipe to the lake bottom, were observed to have failed. The intake structure also appears to be in fair condition with some deterioration of timbers (cracking and softness).

CSP is susceptible to and is showing signs of corrosion which will lead to pipe failure. It is recommended that the duty intake pipe be replaced. There are slip lining options available for CSP pipe which can be explored and will have the added benefit of mitigating disturbance of lake bottom sediments.

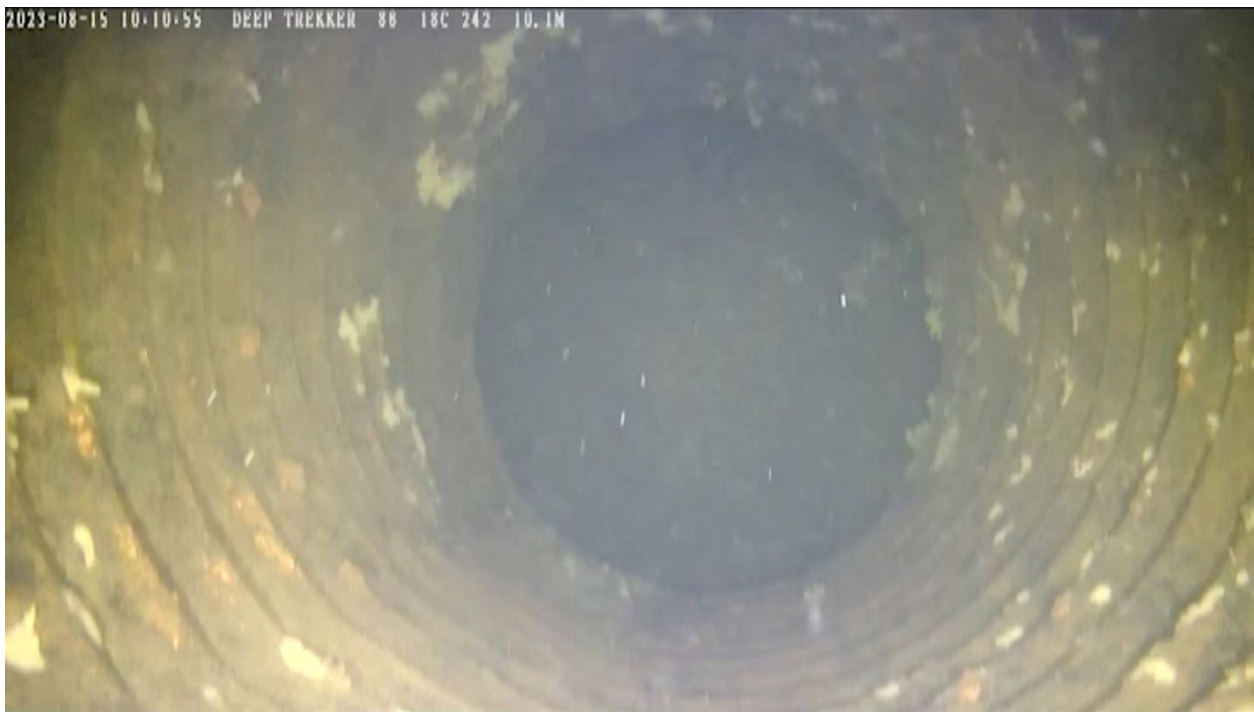
Photograph 5: 90° Section at Duty Intake Structure

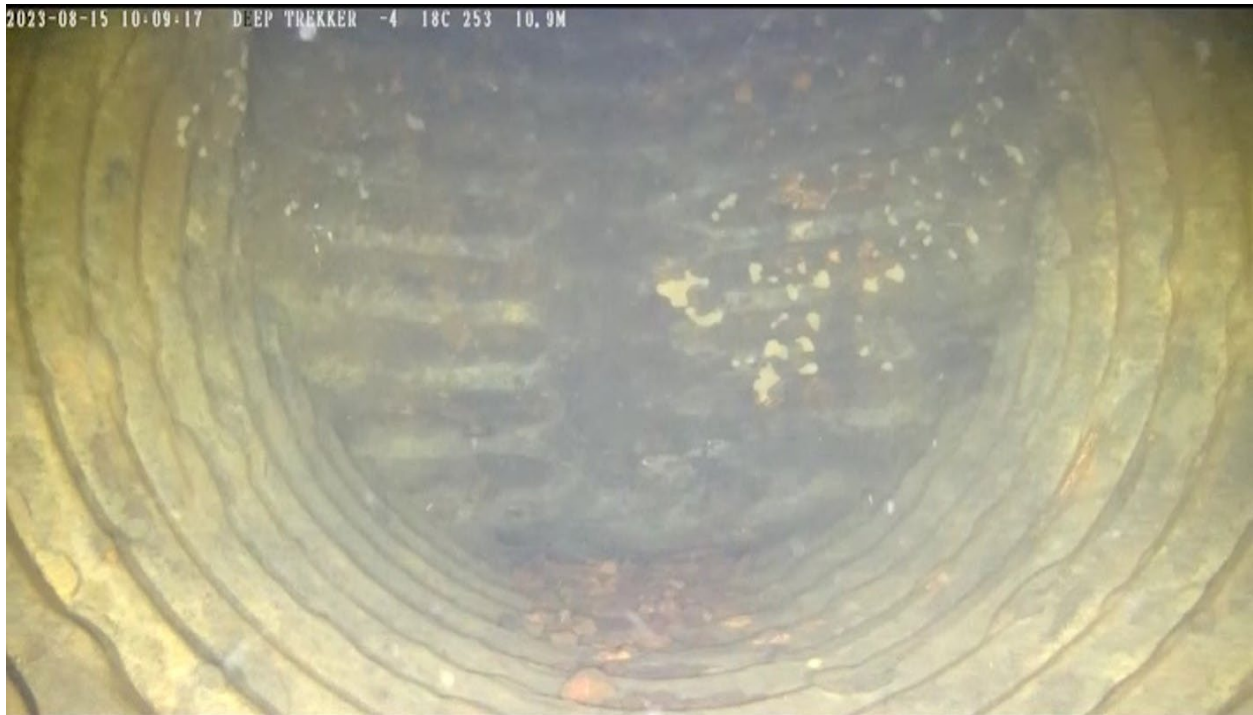
On August 15th, 2023, representatives from the Municipality, Watech and KEC attended at the LLPS to initiate the follow-up interior inspection work. As with the initial inspection, no obvious indications of pipe failure were observed during the follow-up inspection pipe material was confirmed to be CSP along its entire length. The pipe wall appeared to be in good condition along its entire length with minimal sediment buildup at the invert (Photograph 3) as well as a possible pipe puncture observed at the obvert of the pipe (Photograph 4). Areas of apparent surface rust are visible throughout. Ultimately, the ROV was piloted approximately 165m from the LLPS up the 90° section located at the intake structure (Photograph 5). What appeared to be particles resembling dislodged rust particles were observed along the pipe including a build-up located at the bottom of the 90° section (Photograph 6).

Photograph 6: Potential Dislodged Rust Particles at 90° Section of Duty Intake
